Manhole Inspection Summary

Manhole # S45Y__022MH

Record Plat: **45Y** Node: **022** Status: **New Manhole (Not in GIS)** Insp Date: **3/11/08 12:00 AM**

Location Address: **1436 Benjamin Street**

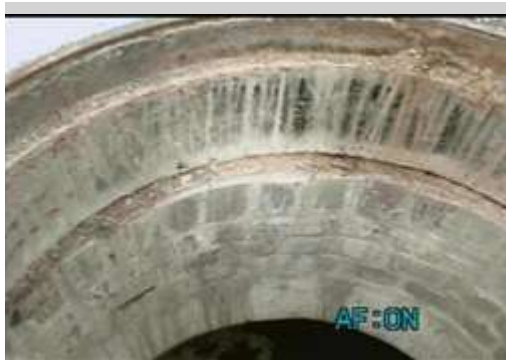
Defect 2

Offset: **1** (in.)

frame offset

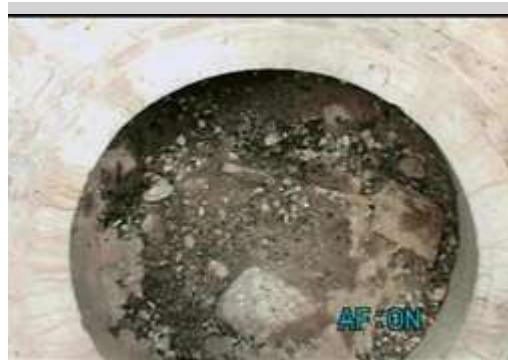
Defect 1

Condition: ☐ Sound ☐ Cracked ☐ Root Intrusion ☐ Deteriorated ☐ Leaks ☒ **Debris**

channel debris

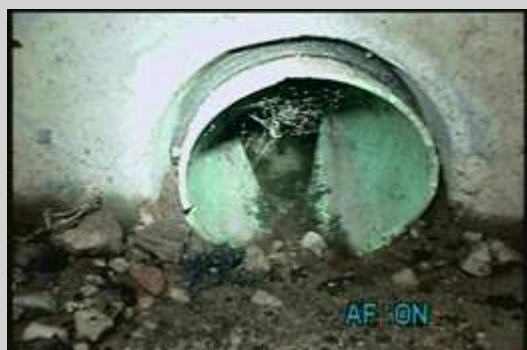
12 O'Clock Outflow

8 in. Circular Gravity Sewer
Pipe Out @ 12 O'Clock

Deposits: ☒ None ☐ Mud ☐ Sludge ☐ Debris ☐ Grease

Infiltration: None
